Failure analysis of microfabricated iridium ultramicroelectrodes in chloride media

Melissa A. Nolan, Samuel P. Kounaves *

Department of Chemistry, Pearson Chemistry Lab, Tufts University, Medford, MA 02155, USA

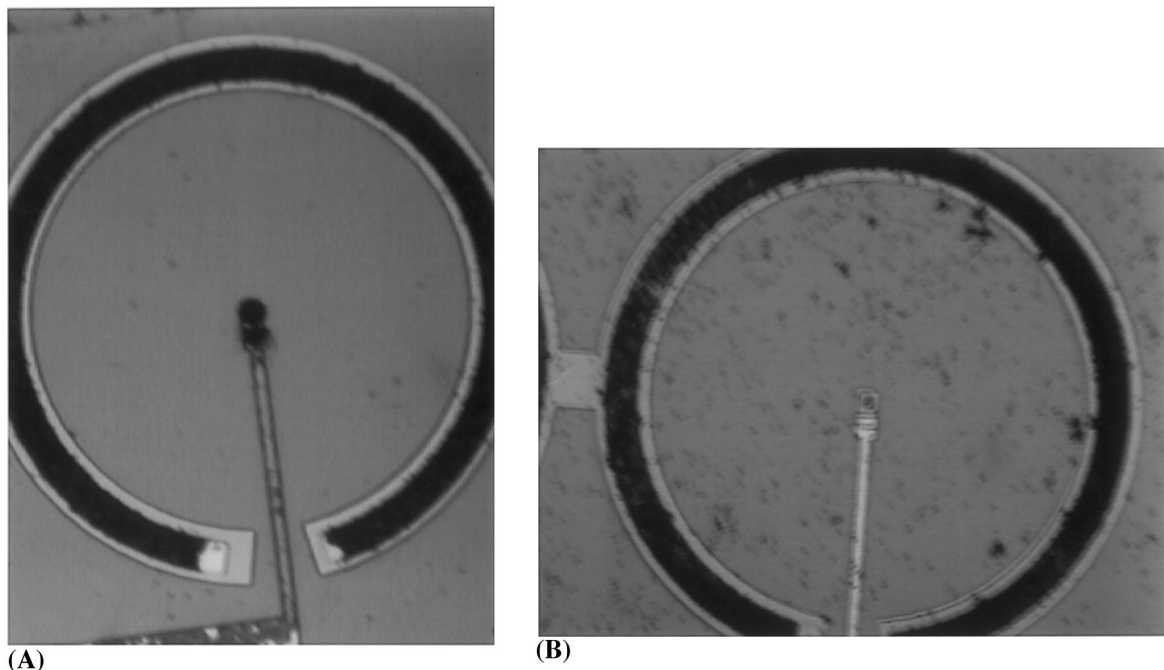
Fig. 2. (A) Array stored in 8 mM Hg in 0.1 M HClO₄ and 4 M NaCl solution for 2½ h. (B) Array stored in 8 mM Hg in 0.1 M HClO₄ solution directly under a Ag/AgCl (3 M NaCl) reference electrode.

tained. For chloride concentrations > 0.1 M the accumulations were very abundant, as shown in Fig. 2 (A, B) and no electrochemical response was obtained. Even though the accumulations appeared black or brown under the polarizing microscope, they were white when viewed with the naked eye.

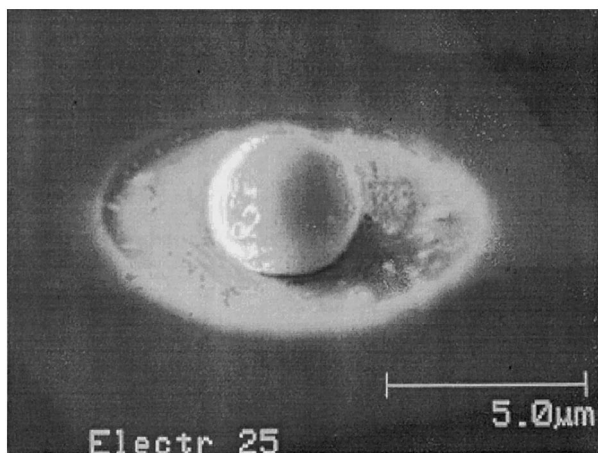
The images obtained using AFM were too noisy and difficult to use for interpreting any of the features on the iridium UME surfaces. This led us to conclude that the accumulations were probably in a liquid-like state. Auger SEM was then used to further analyze these accumulations. The SEM images, a typical one shown in Fig. 3, revealed the accumulations on the iridium UME surfaces to be roughly spherical. During auger analysis the sphere ‘collapsed’ leaving a solid residue which the analysis then identified to be mercury and chloride. Because of this ‘collapse’ we concluded that the accumulated material was probably composed of liquid mercury spheres with an outer coating of Hg₂Cl₂. The AFM images (Fig. 4) of the material remaining on the iridium UMEs revealed a cluster of pyramids. This type of structure formed under the same conditions has been previously analyzed and shown to be pyramidal crystals of Hg₂Cl₂ [12].

Fig. 3. An SEM image of an Ir-UME before analysis by Auger.

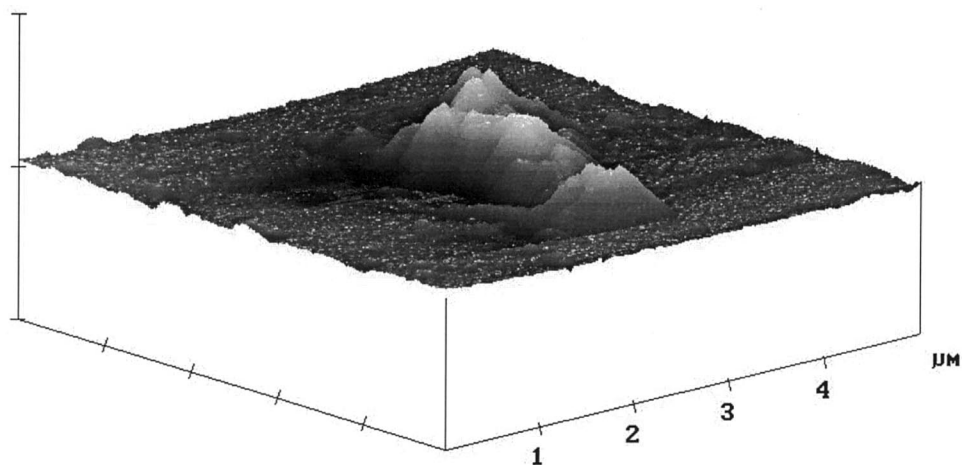
Fig. 4. AFM image of the material on the Ir-UME surface after the Auger SEM was performed on the array shown in Fig. 3.

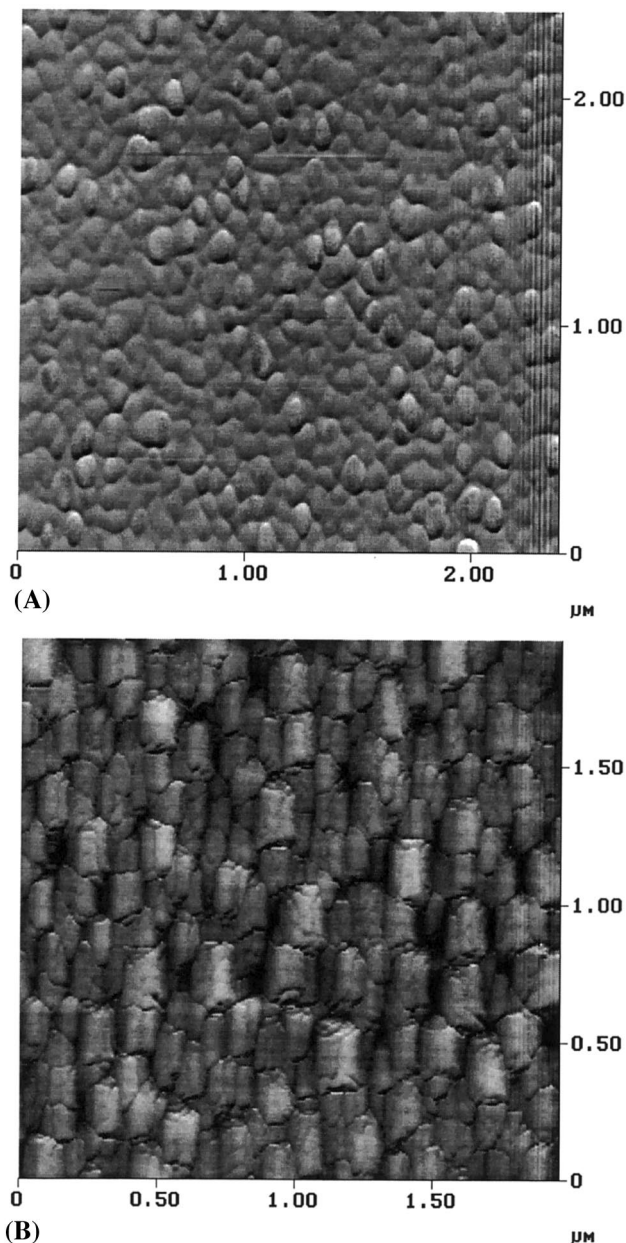
Since the accumulations seemed to occur only when both mercury and chloride ions were present in a solution, it seemed reasonable that they would not appear with only one component in solution. However, placing a sensor directly under a reference electrode in a solution containing only 0.1 M HClO₄ for about 2½ h resulted in the formation of a thin film on the exposed iridium surfaces. This film though, differed substantially from the previously reported accumulations. Fig. 5 shows AFM images of a typical Ir UME surface (A) before and (B) after, exposure to the reference electrode. The Ir UME surface appears radically different. Analysis of this coating by Auger SEM identified the film components as silver and chloride.

Fig. 5. AFM image of the iridium UME surface (A) before and (B) after being stored in 0.1 M HClO_4 for $2\frac{1}{2}$ h directly under a Ag/AgCl (3 M NaCl) reference electrode.

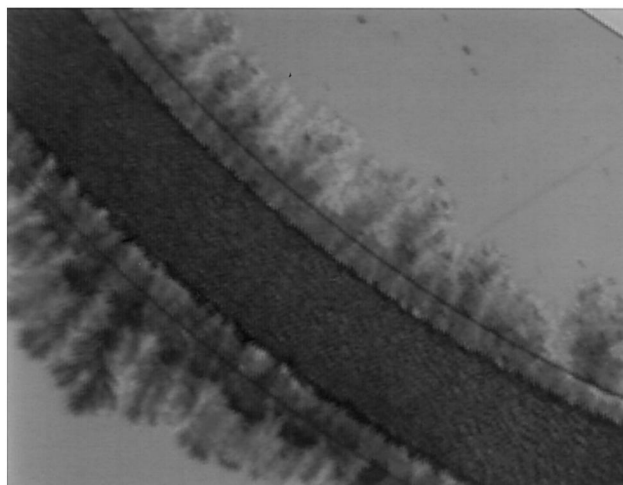
Fig. 6. Array stored in saturated silver chloride solution for 1 h.

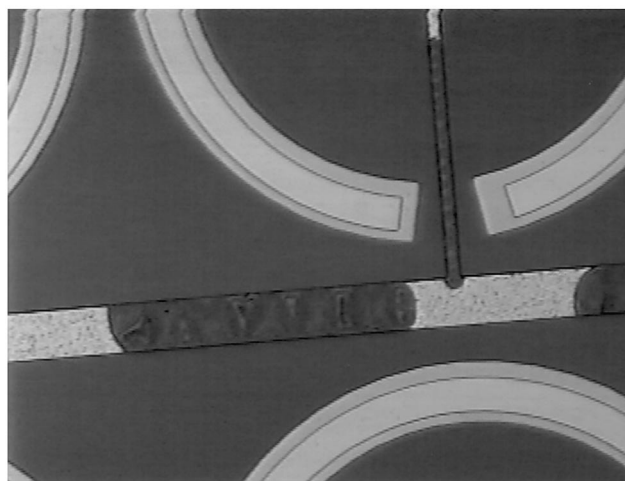
Before in-situ observations were carried out on the sensor, the aluminum traces on the chip were verified to be intact. When a drop of concentrated hydrochloric acid was placed on the chip, gas bubbles were immediately observed across most of its surface. On closer observation, it was clear that the aluminum traces were dissolving and hydrogen gas was being evolved at those points. The reaction was observed and recorded by the video system. Fig. 7 (a) is a typical frame taken by the video showing the dissolution of an aluminum trace. Clearly, the insulating layer is still intact but the solution has penetrated under the insulating layer in several

Fig. 7. In situ observations of an array with a drop of concentrated hydrochloric acid on it. (a) Area where the aluminum dissolved. (b) Aluminum reaction in progress.

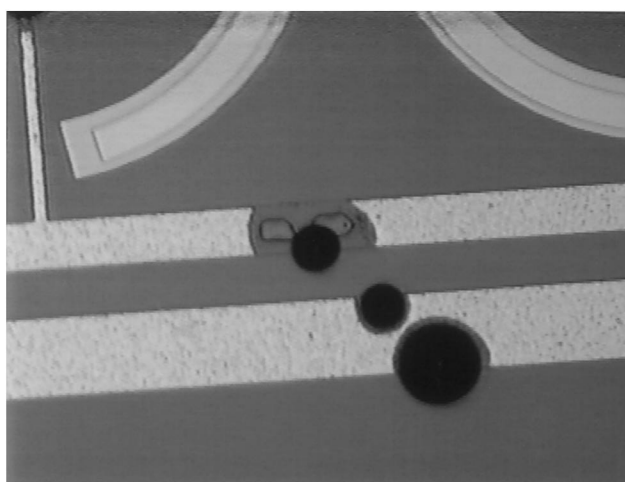
locations and dissolved the aluminum trace. Fig. 7 (b) shows the sensor surface at the beginning of the reaction. One can clearly see the gas bubbles being evolved at a single point on the insulating layer. In one instance we can clearly see the formation of a single gas bubble at the same point where the solution has penetrated the insulating material. It is interesting to note that the reaction is occurring under the layer. Apparently the solution has entered the channel at a single pin-hole while the gas appears to be escaping from the same point. This appeared to be the case for almost all the pin-hole reaction sites over the entire sensor, usually one pinhole at each failure point. Even though the failure was widespread and catastrophic, it occurred in two main regions of the circuitry: (1) where the aluminum and iridium overlapped; and (2) at the edges the aluminum traces, areas of thinner insulation.

pin-holes. This seems reasonable since the failure and the resulting generation of gas, begins at a single distinct location (see Fig. 7b). If the penetration occurred by diffusion, it would most likely be much more widespread and over more irregular areas. In addition, the fact itself that the gas appears to escape through these single pin-holes lends even further weight to this theory. Unfortunately, attempts to provide direct evidence for this mechanism via microscopic observation failed. The pin-holes, due to their size, cannot be observed by optical microscopy. Both SEM and AFM were carried out on these chips but no pin-holes could be seen. However, one problem is the relatively small number of these holes present. There is a very, very, low probability that a pin-hole could be found on the surface within the small micro/nano-meter area observable during each scan by these latter techniques.
